Wood Destroying Insect Inspection Report

2827 Sample Address Road , Indianapolis, IN 46241

House & Garage

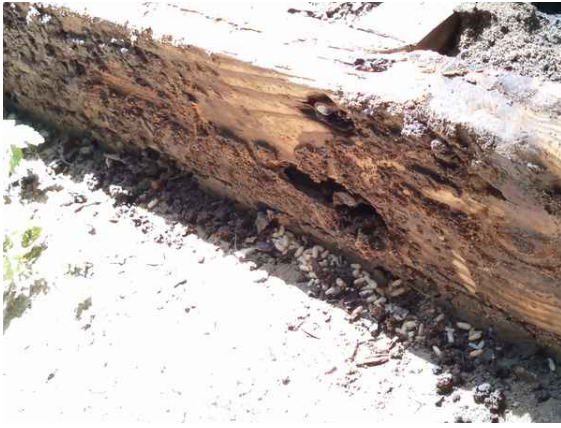
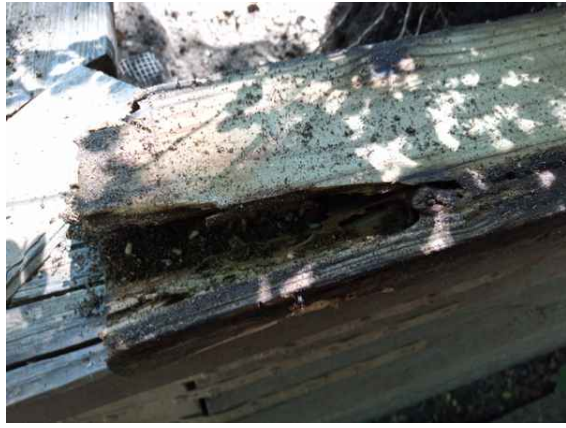
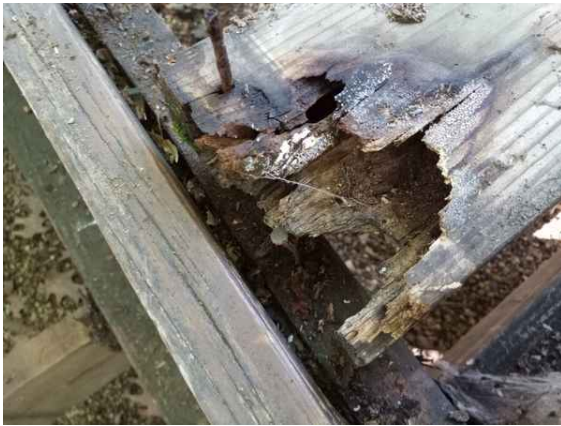
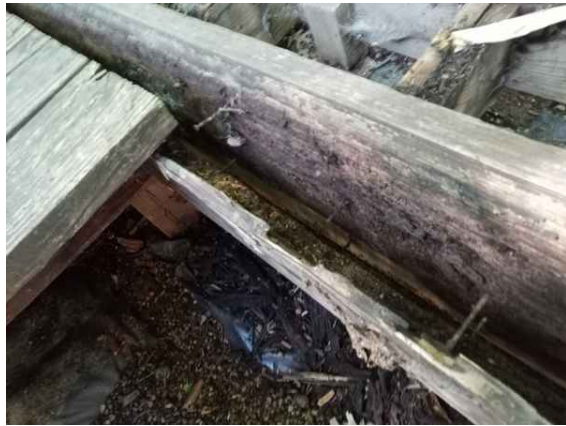
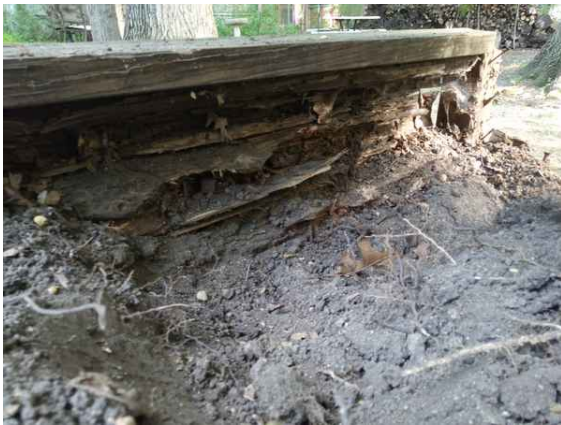
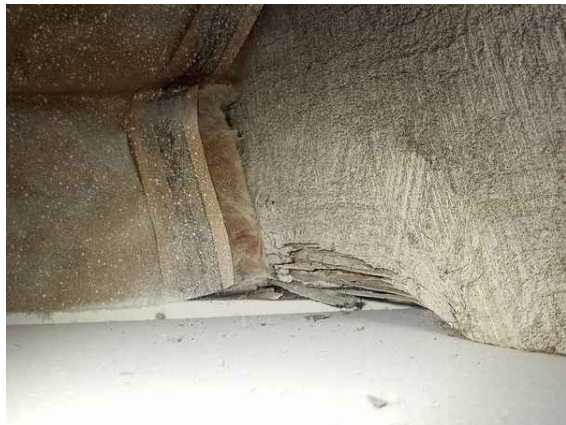
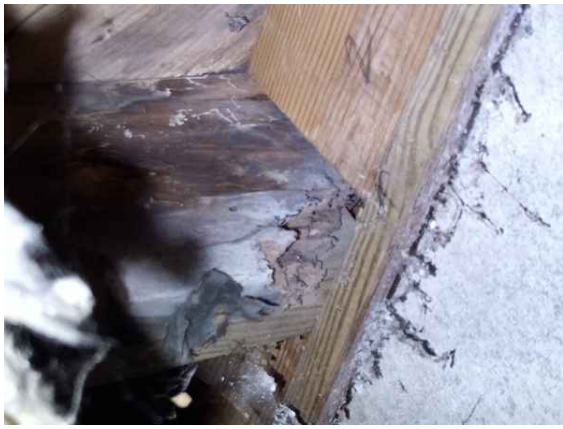
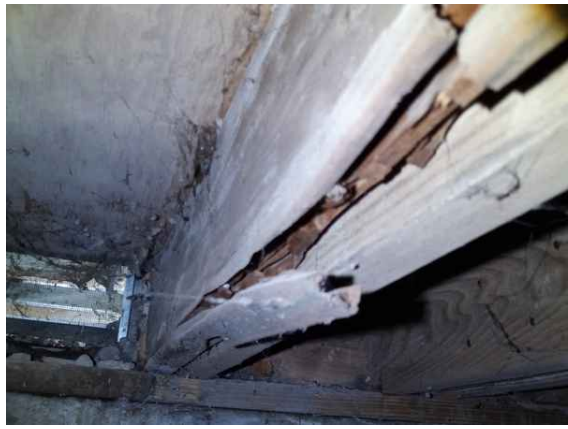
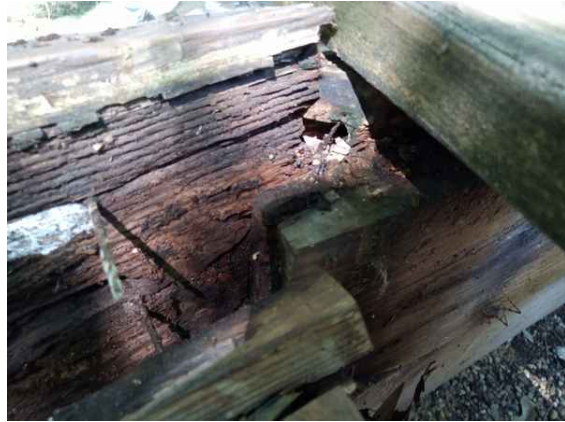
Photos & Attachments

☒ 1. Live insects (description and location): There is evidence of termite and carpenter ant activity at the back damaged deck.

☒ 3. Visible damage from wood destroying insects was noted as follows (description and location): There is evidence of termite damage at the back deck and basement joists. There is evidence of termite and carpenter ant damage at the back deck.

☒ Recommend action(s) and/or treatment(s) for the control of: Termites and carpenter ants. Consult a qualified pest control contractor to further evaluate the extent of damage, determine the appropriate method of treatment/repair, and determine the proper course of action.
